## City Historic Buildings Survey

*Phase I: Evaluation of Historic Significance of City Buildings*

# **City Historic Buildings Survey Newton, Massachusetts**

### **Evaluation of Historic Significance of City Buildings**

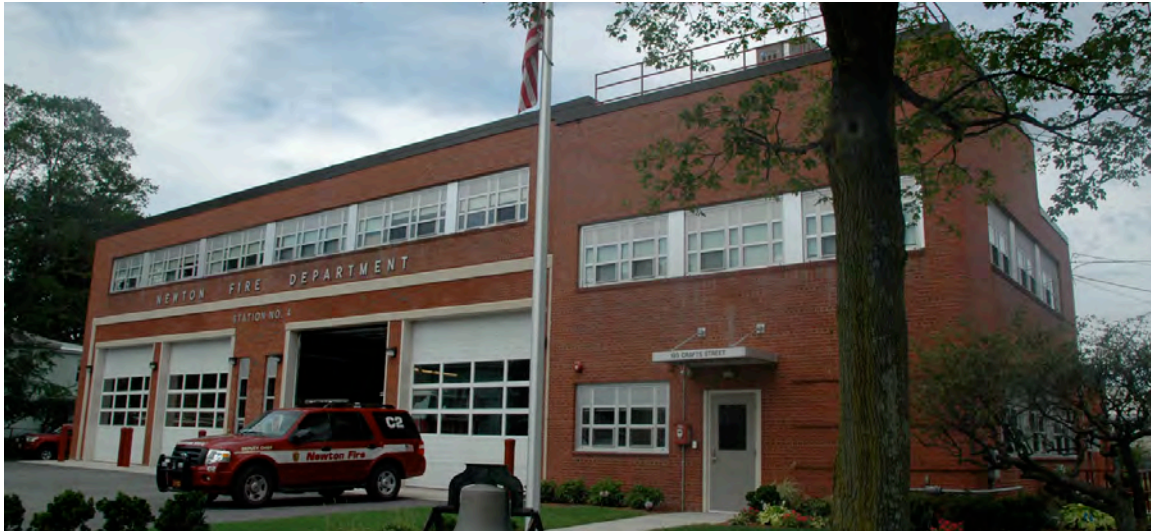
## Fire Station #4 (Newtonville)

*Openings:* Horizontal bands of windows. The original sashes have been replaced with aluminum windows with multiple divided lights. Metal roll down garage doors with vision lights at the four bays of the garage wing.

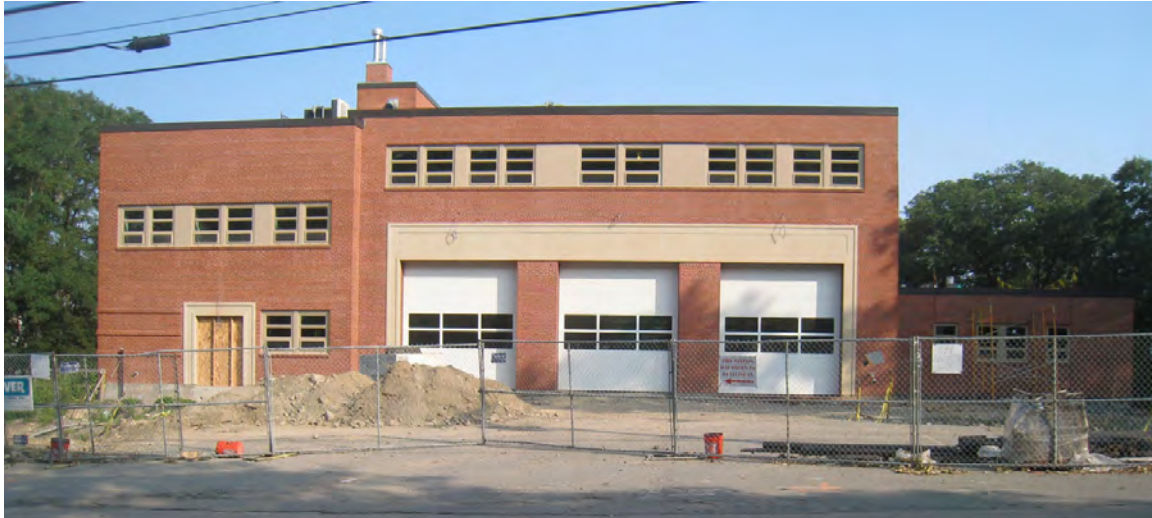
## Fire Station #7 (Highlands/Upper Falls)

*Openings:* Horizontal bands of replacement aluminum windows consisting of groups of two sashes with two fixed panes over an operable hopper separated by metal infill panels. Metal roll down garage doors with vision lights at the garage wing.

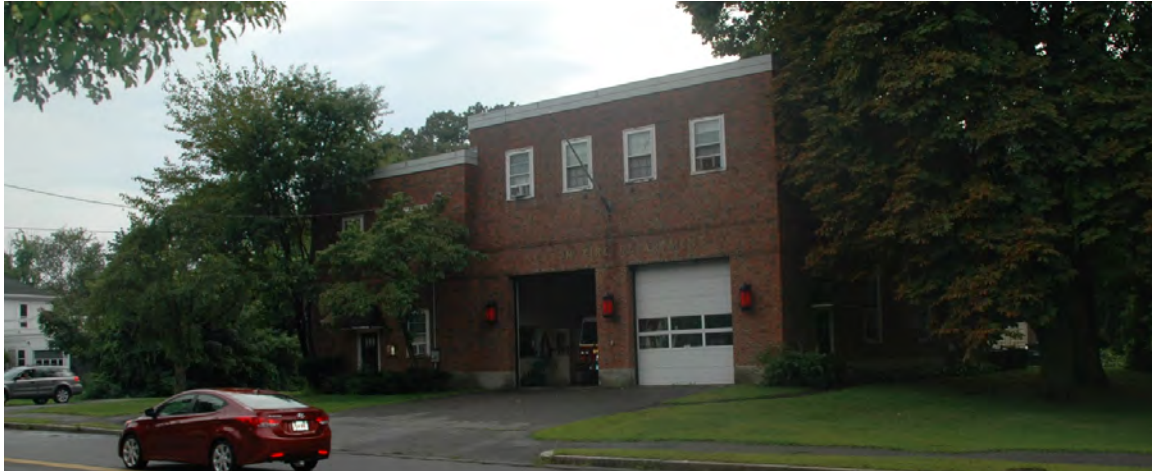
## Fire Station #10 (Oak Hill)

Address: 755 Dedham Street

Year of Construction: 1948

*Materials:* Red brick with concrete foundation and wood window and door casing.

Well-designed utilitarian structure, but with few exterior architectural features.

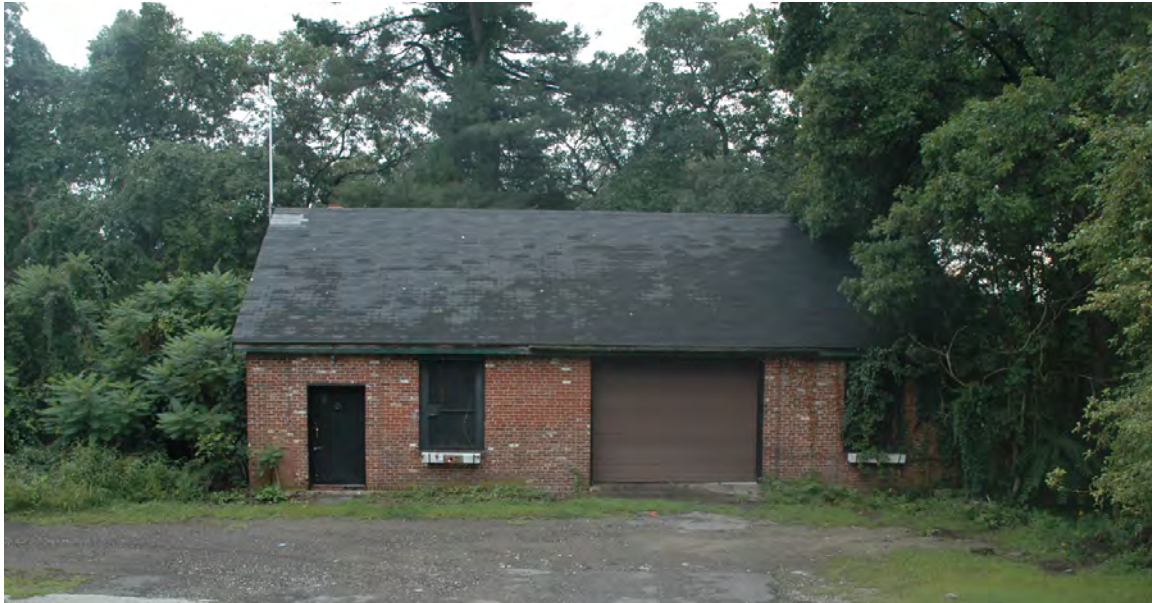
## Winchester Street Garage

*Materials:* Brick with fieldstone foundation.
